Bathing establishment fact Sheet

Name of bathing establishment	COLOMBO ALESSANDRO
Address	Via Adelaide Ristori, 5
City	Viareggio (LU)
Contacts	Tel +39 0584 46574
Website	https://bagno-colombo-alessandro.business.site/

TESTED BY: Handy Superabile - Social Promotion Association in summer 2023

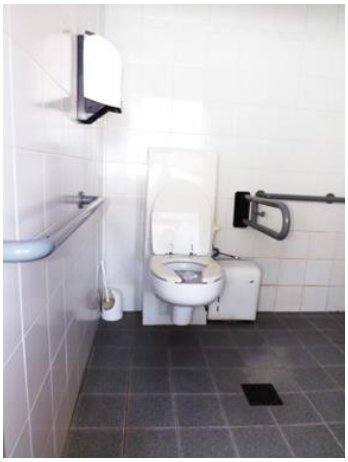
Number of toilets accessible/usable by guests with reduced mobility	1
Access to the venue	Via the same ramp that leads to the bar restaurant: length 700 cm, width 100 cm, slope 6.9%, right handrail
Useful width of entrance door	87 cm
Toilet height	50cm
Open front toilet seat	YES
Support handles	on both sides of the toilet
Flexible shower next to the toilet	YES
Free space on the sides of the toilet	to the left greater than 90 cm To the right 30cm Front greater than 90 cm
Electric bell/telephone	YES
Washbasin with space underneath for a wheelchair	70cm
Height from the ground to the lower edge of the mirror	not sufficient for use by people in a wheelchair
Baby changing table	not detected
