Bathing establishment Fact Sheet

| Bathhouse name | Aurora 2 |
| Address | Viale Roma n. 44 |

TESTED BY: [Handy Superabile - Social Promotion Association](#) in summer 2023

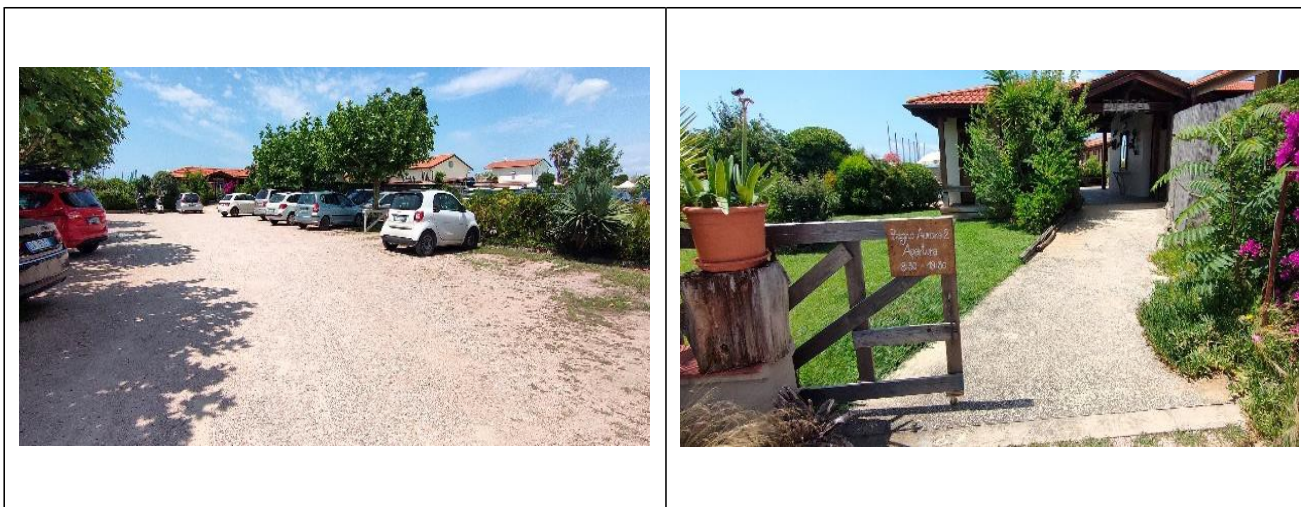
| Pathway from the car park to the entrance | flat on a gravel surface that can make it difficult for wheelchair users to move around |
| Usable door/entrance width | more than 90 cm |

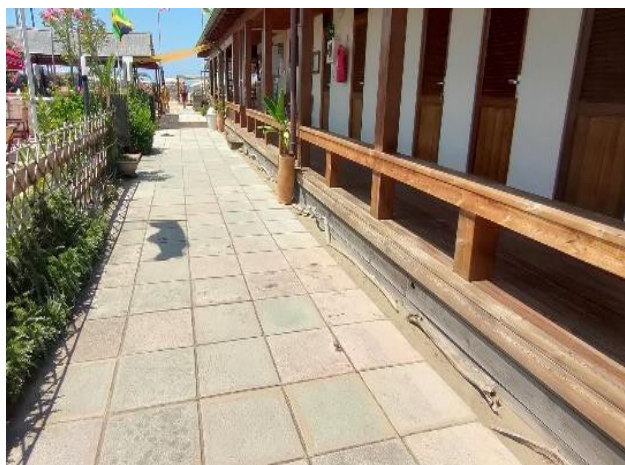
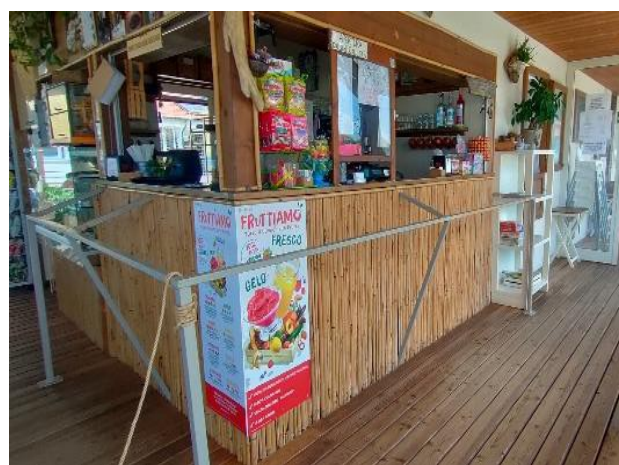
| Access to the premises | by ramp length 462 cm, width 260 cm, gradient 4.3% |
| Usable door/entrance width | more than 90 cm |
| Bar counter | more than 100 cm |
| Types of tables | 4-shank and with central support |
| Space underneath the tables from the floor | 68 cm |

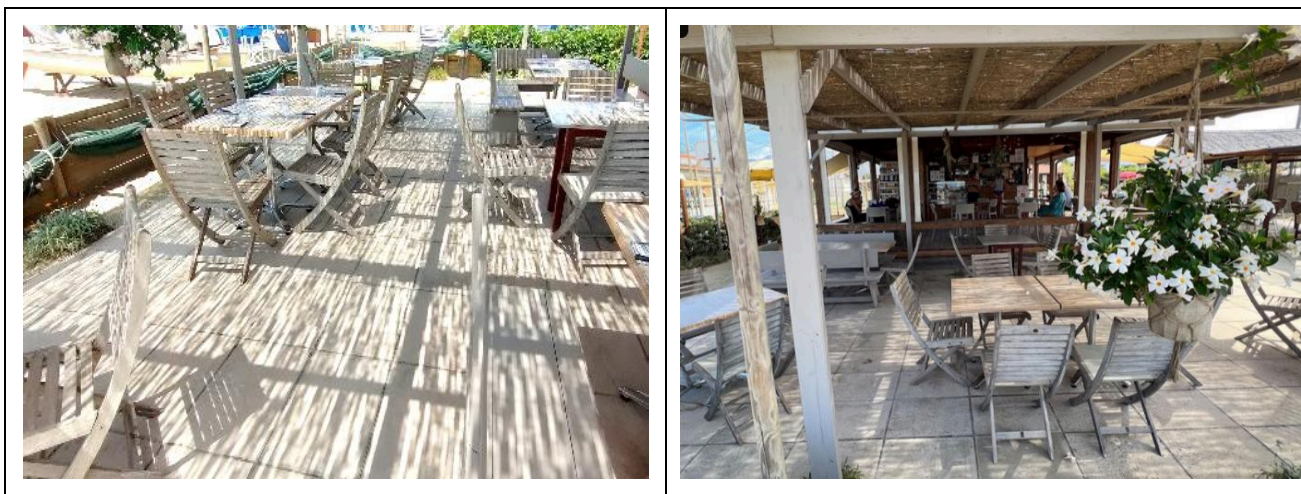
| Indicate whether the pathways connecting the entrance to the beach are flat or with ramps in addition to those already described | Obstacle-free paths |

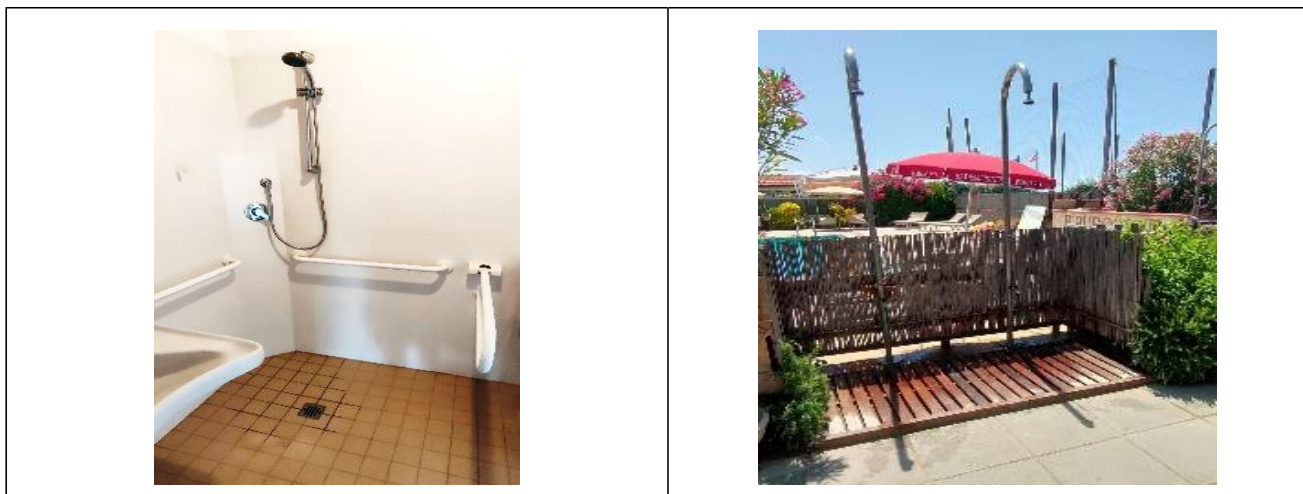
| Shower type | open-type |
| Floor-level shower | YES |
| Shower chair | missing |
| Grab bar | YES |
| Presence of shower head or ups and downs | Sliding rails with lowest point height 138 cm |

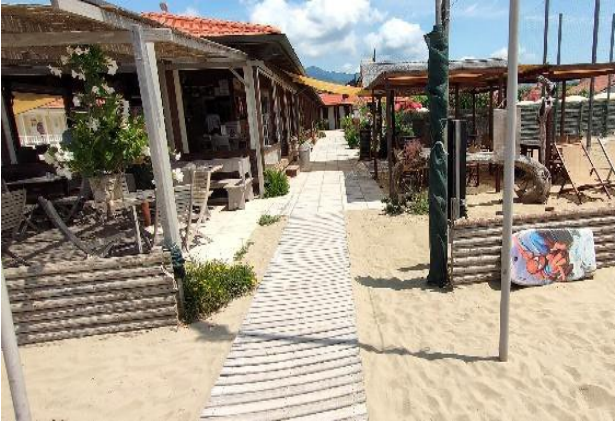
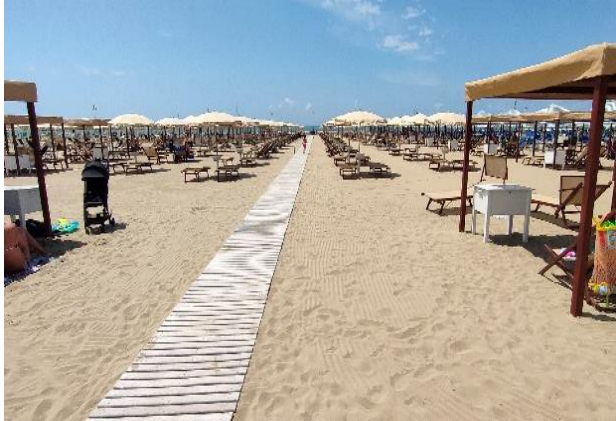
| Walkway to reach the umbrellas | YES |
| Type of walkway | wood |
| Walkway width | 100 cm |

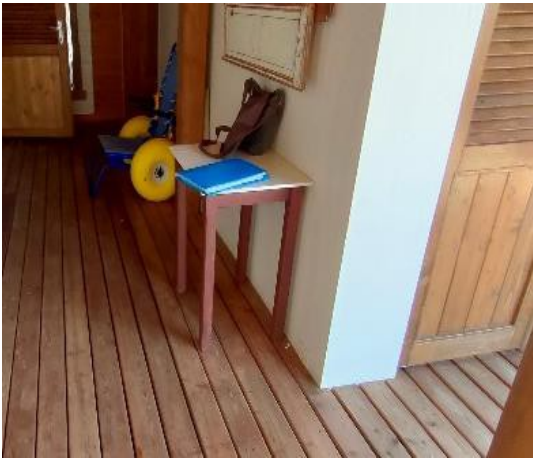
| <p>Removable Platform between the walkway and the umbrella station to facilitate the passage and parking wheelchair</p> | <p>YES</p> |
| <p>Amphibious beach chair available for helping people with reduced mobility to enjoy swimming (owned by the establishment or by association)</p> | <p>YES</p> |

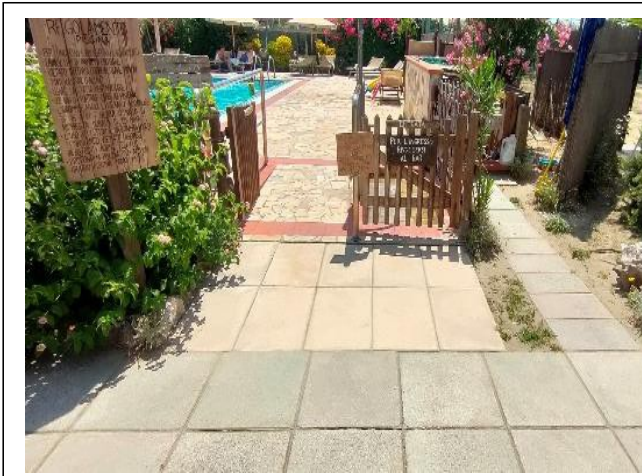
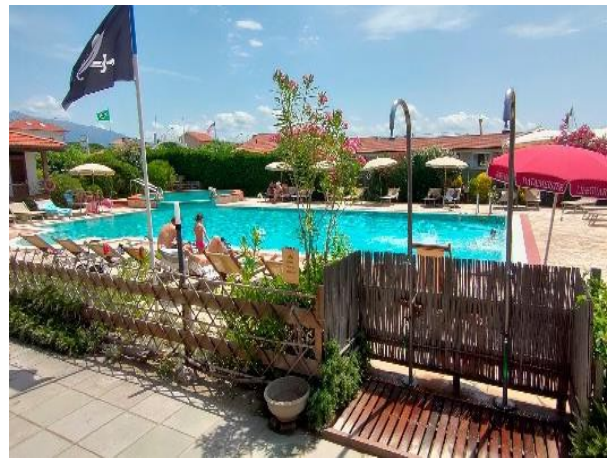
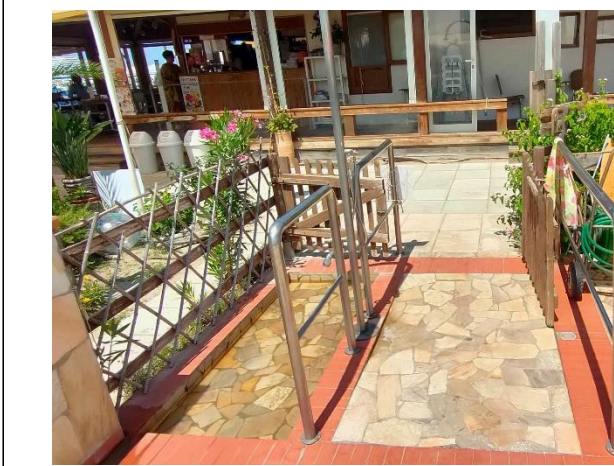
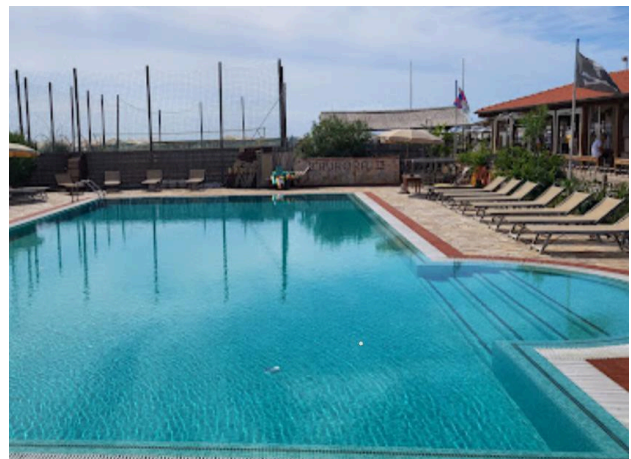
| Access to the swimming pool | via two ramps: the first ramp, which also leads to the toilet and bar room: length 462 cm, width 260 cm, slope 4.3%, handrail on the right; the second ramp: length 500 cm, width 260 cm, slope 5% |
| Useful width of the entrance gate | more than 90 cm |
| Access to the pool | via ramp with steps |
| Bathing aids for guests with reduced mobility | amphibious chair |
